**Tanner's Creek Fly Ash  
Pond Assessment Report**

**Lockheed Martin**

**June 2009**

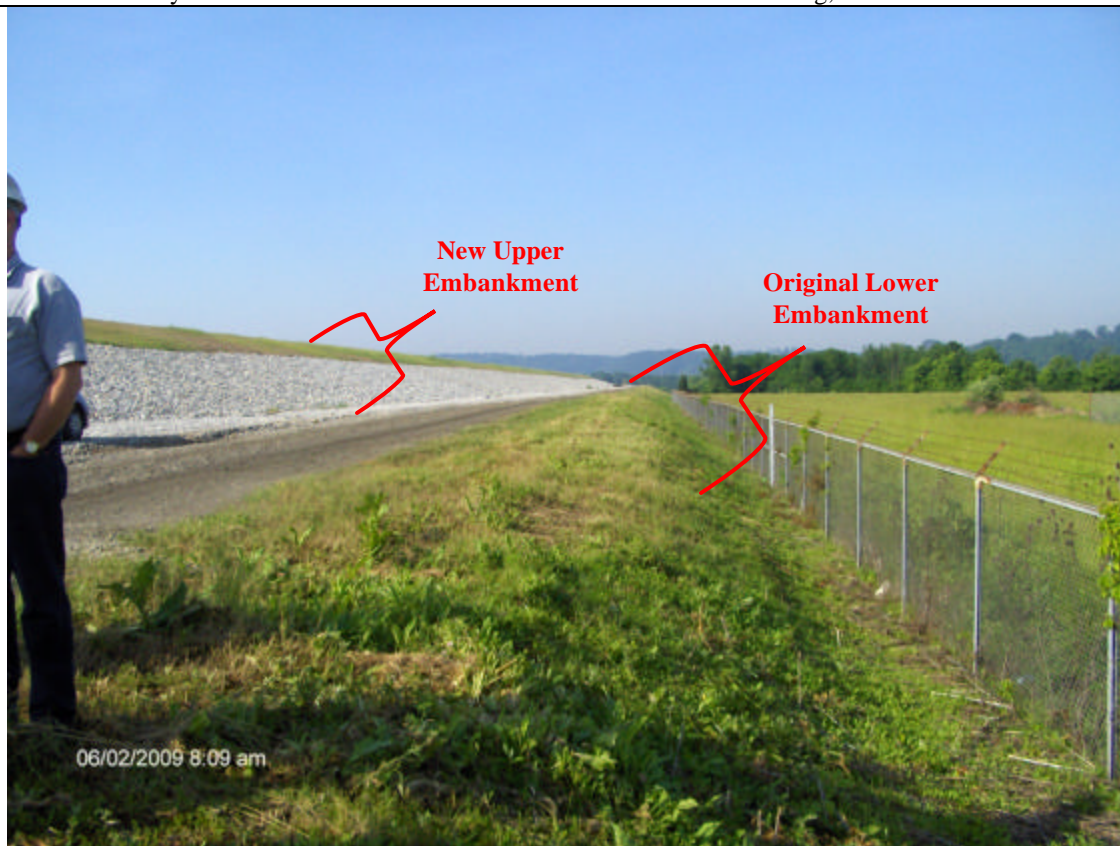
Photo Number:  
1

Description:  
View along  
west  
embankment.  
Note original  
lower  
embankment  
and new upper  
embankment.

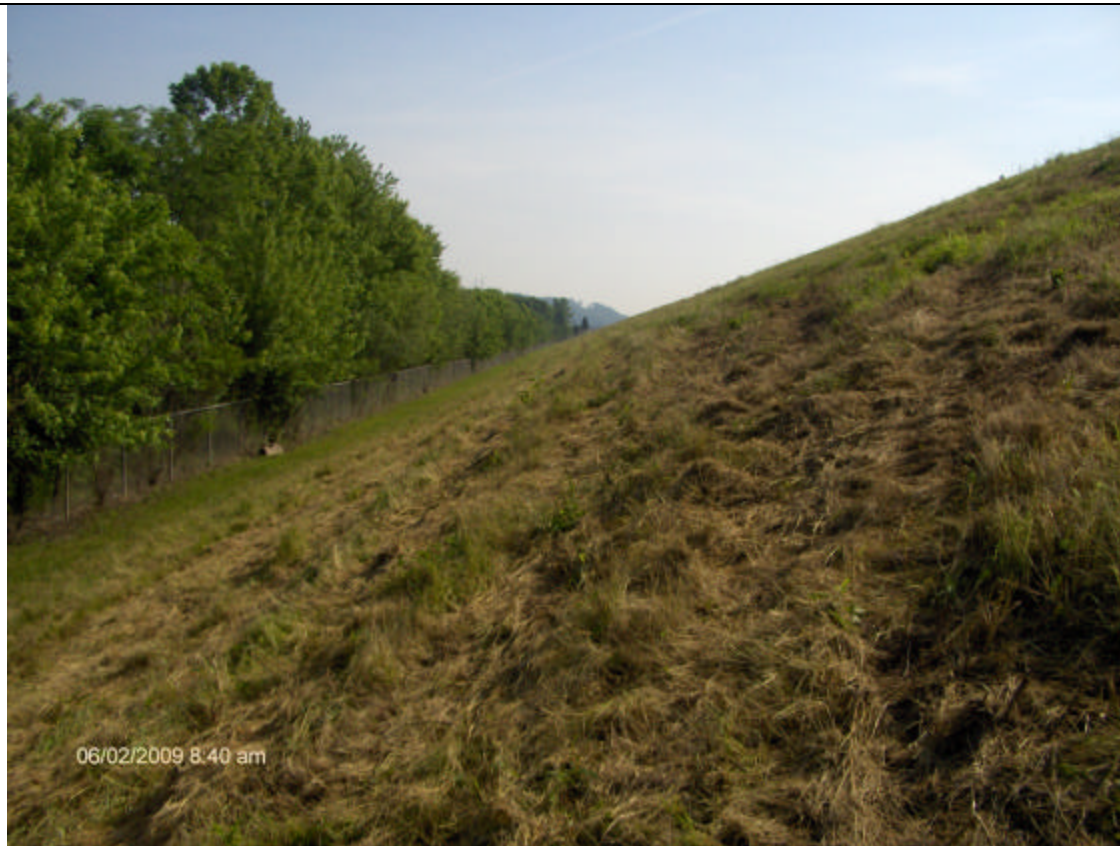
Photo Number:  
2

Description:  
View along  
west side of  
original lower  
embankment.

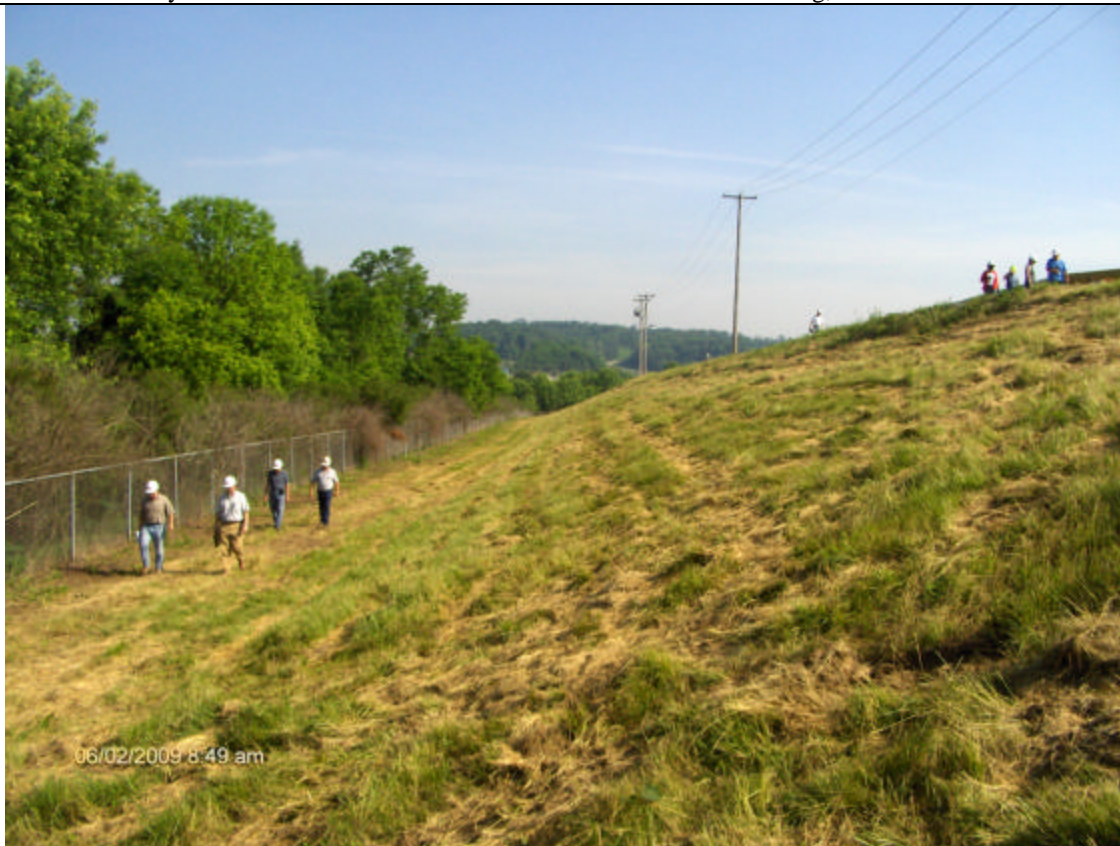
View along south embankment of original structure.

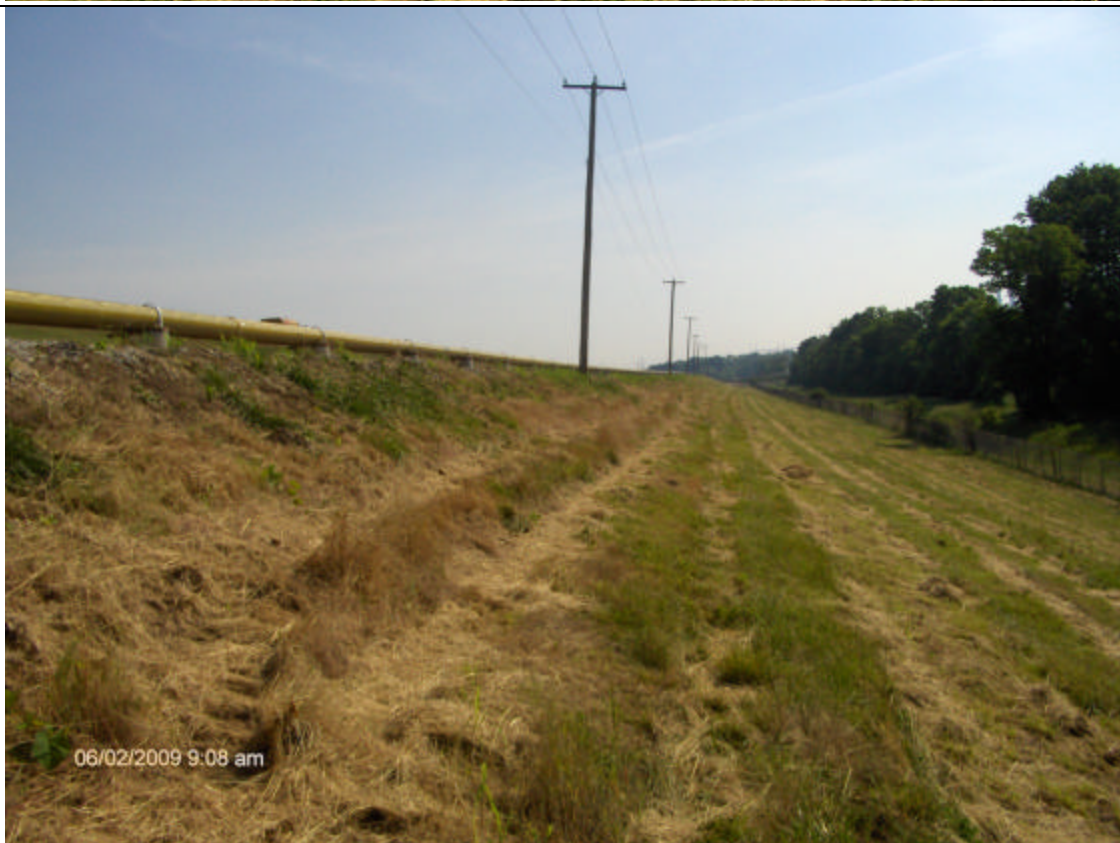
View along east embankment of original structure. Note FRP piping along crest of original dike.

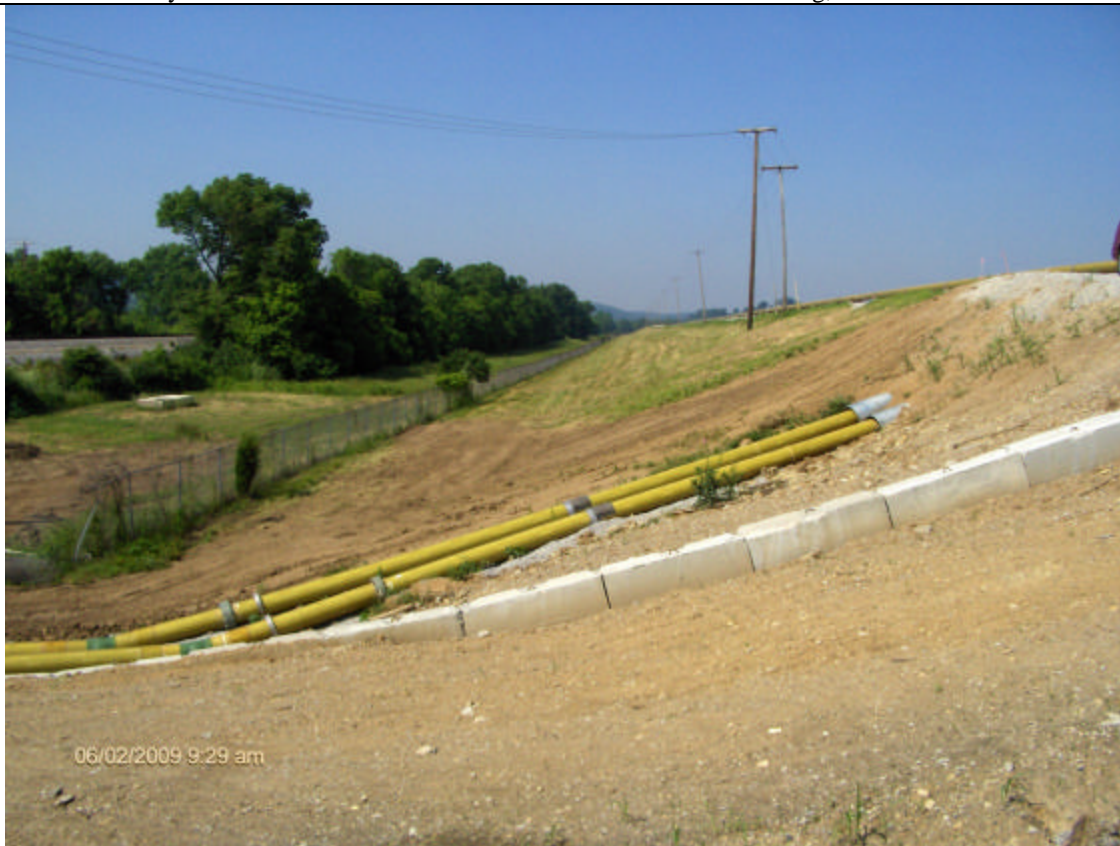
Photo Number:  
5

Description:  
View along east  
embankment of  
original  
structure. Note  
new access  
drive to road on  
crest of original  
dike and FRP  
discharge piping  
in foreground.

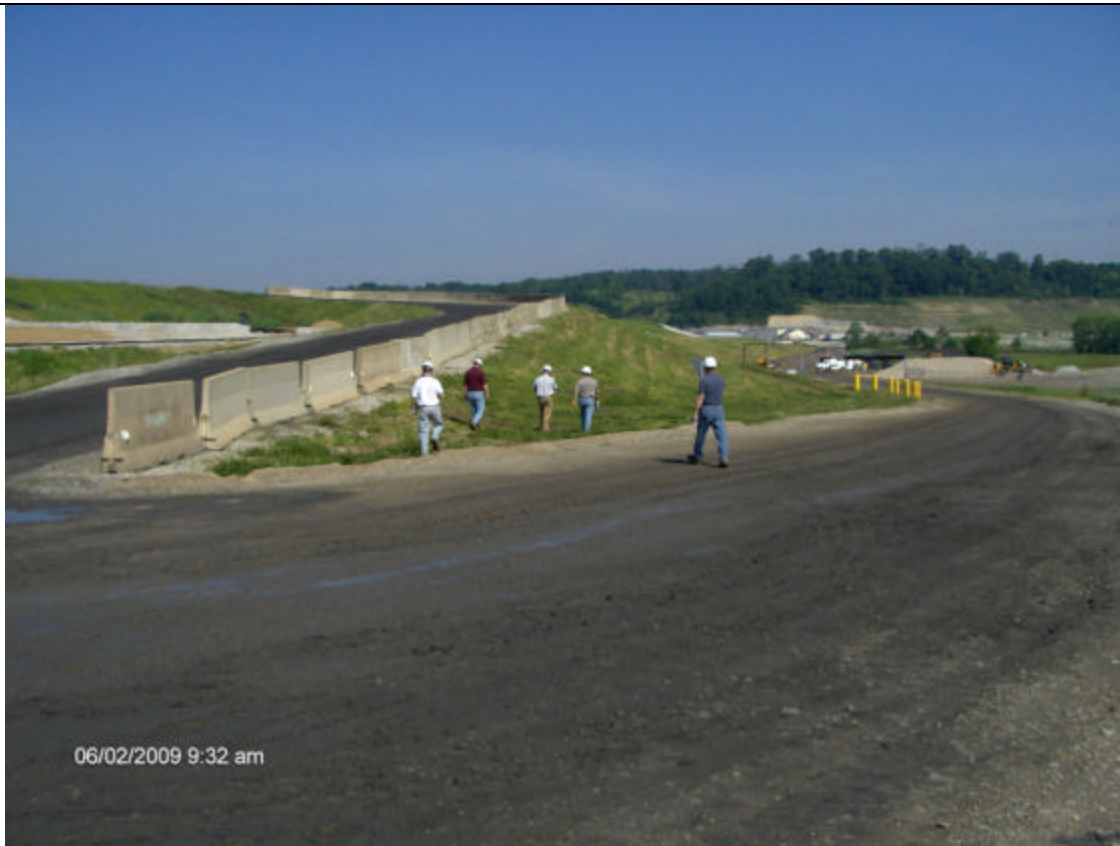
Photo Number:  
6

Description:  
View of north  
embankment  
and construction  
access road to  
Upper Pond for  
excavation work  
and transport of  
excavated fly  
ash.

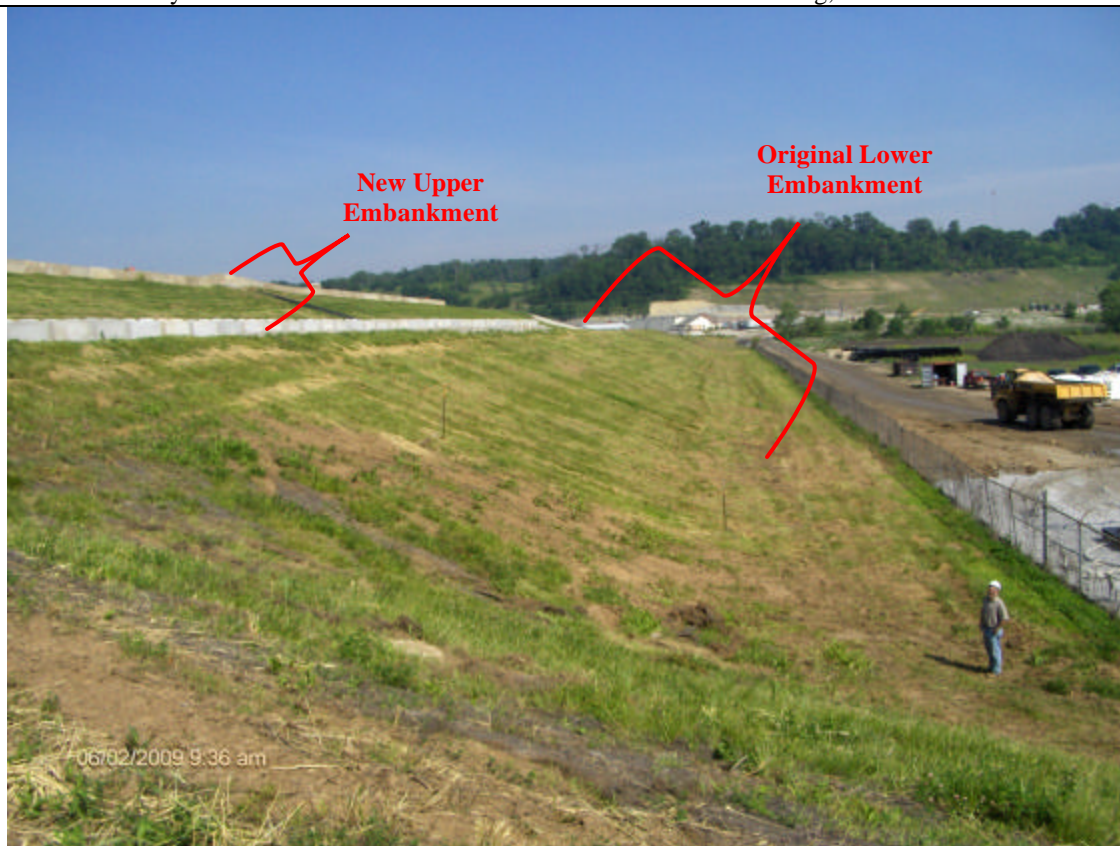
Photo Number:  
7

Description:  
View of north  
embankment.  
Note original  
lower portion  
and new upper  
portion of  
embankment.

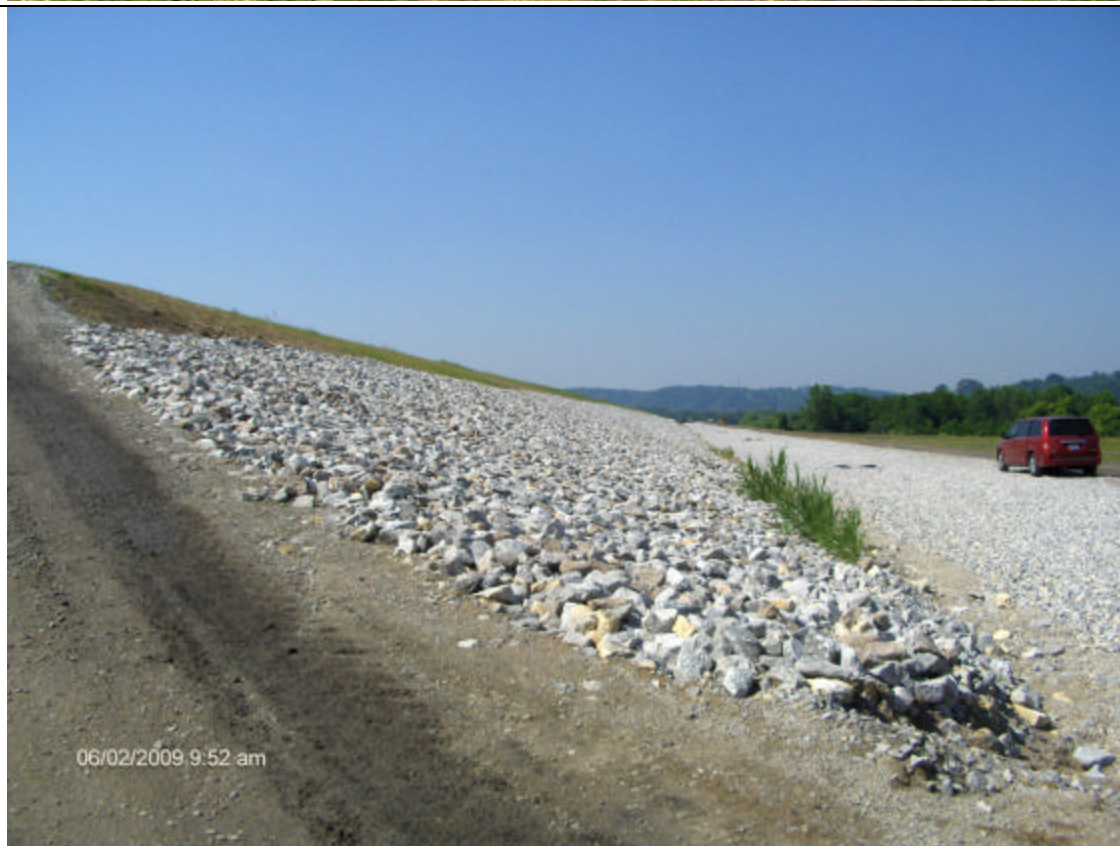
Photo Number:  
8

Description:  
View along  
west  
embankment of  
Upper Pond.  
Note roadway at  
left leads up to  
crest of new  
upper  
embankment.

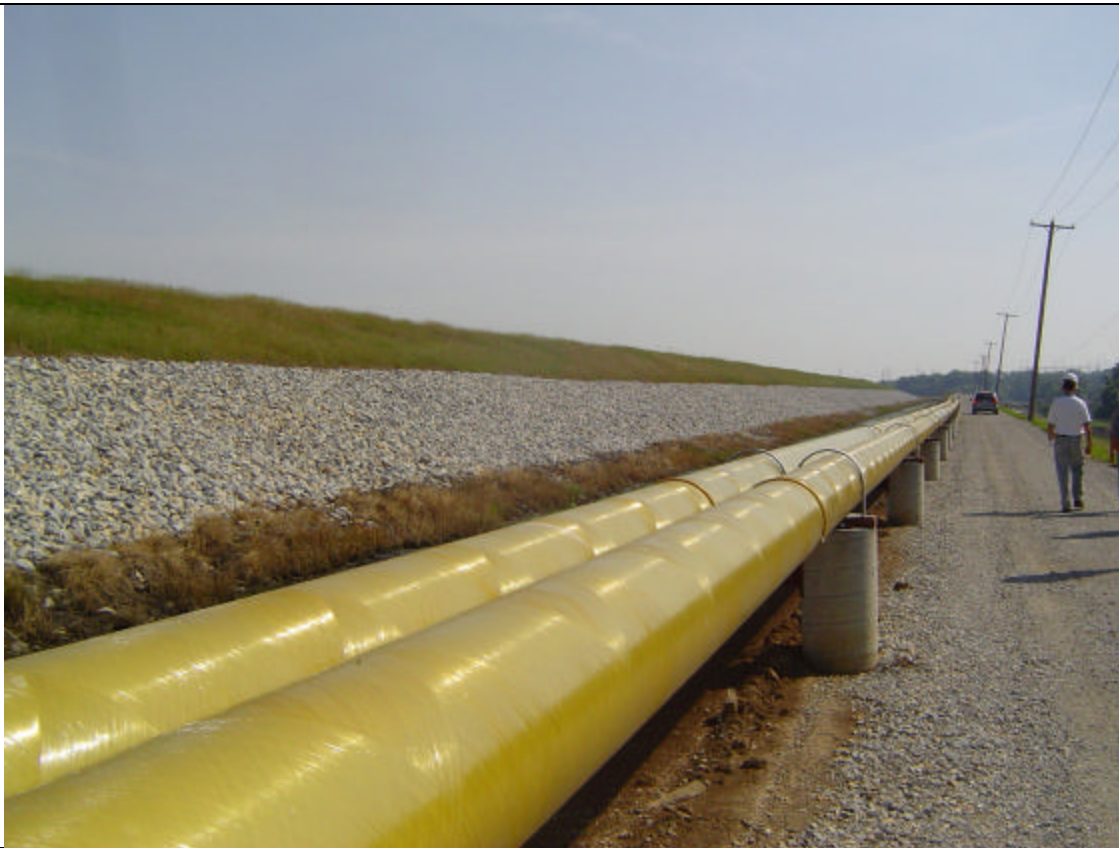
Photo Number:  
10

Description:  
View along east  
embankment of  
Upper Pond.  
Discharge  
piping from  
Clear Pond  
shown in  
foreground.

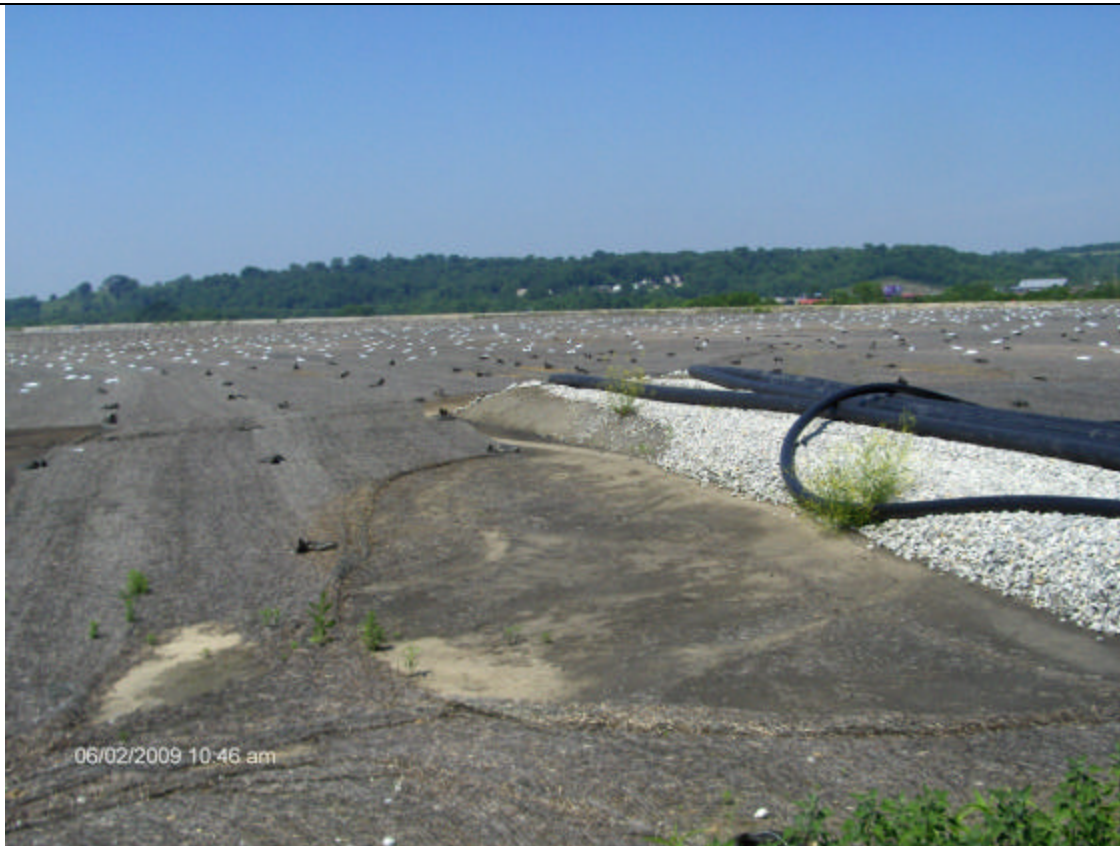
Stored ash in west half of Upper Pond. Inlet piping shown at right. Note sandbags placed on straw matting to control dust.

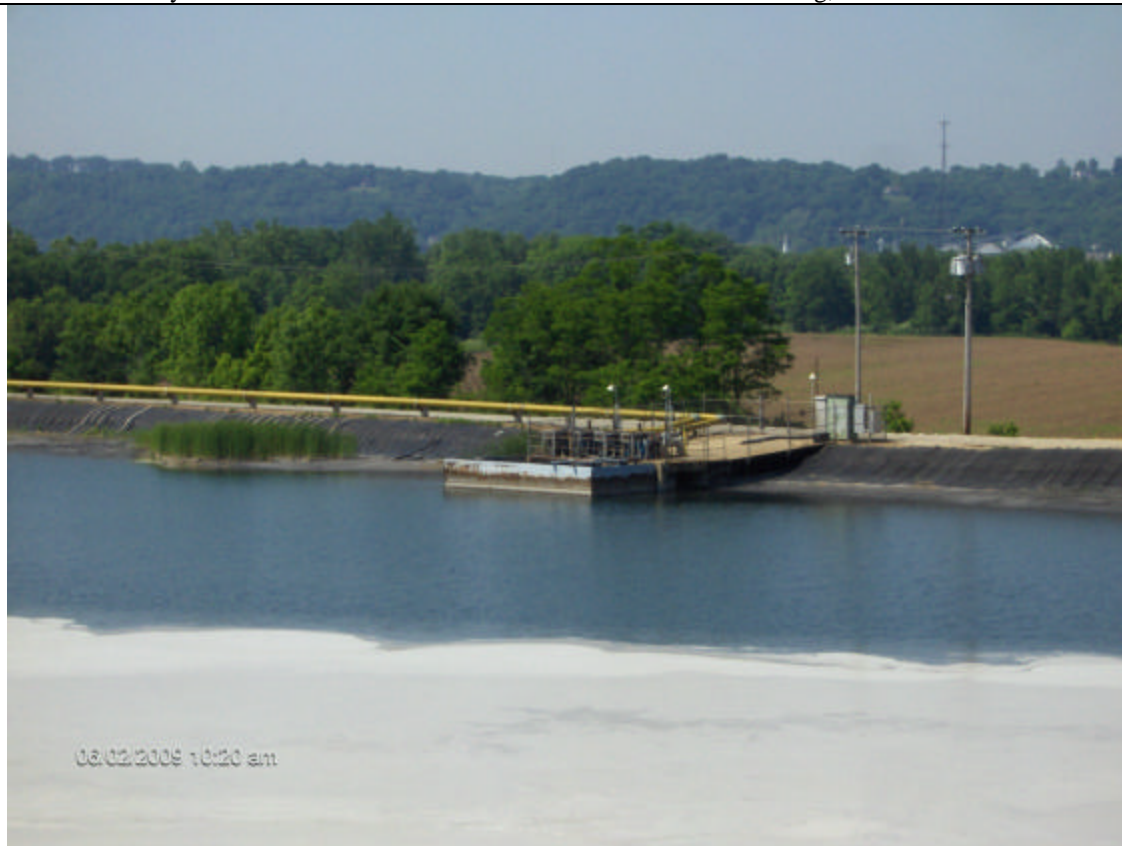
Photo Number:  
15

Description:  
Discharge  
pumping  
equipment in  
Clear Pond

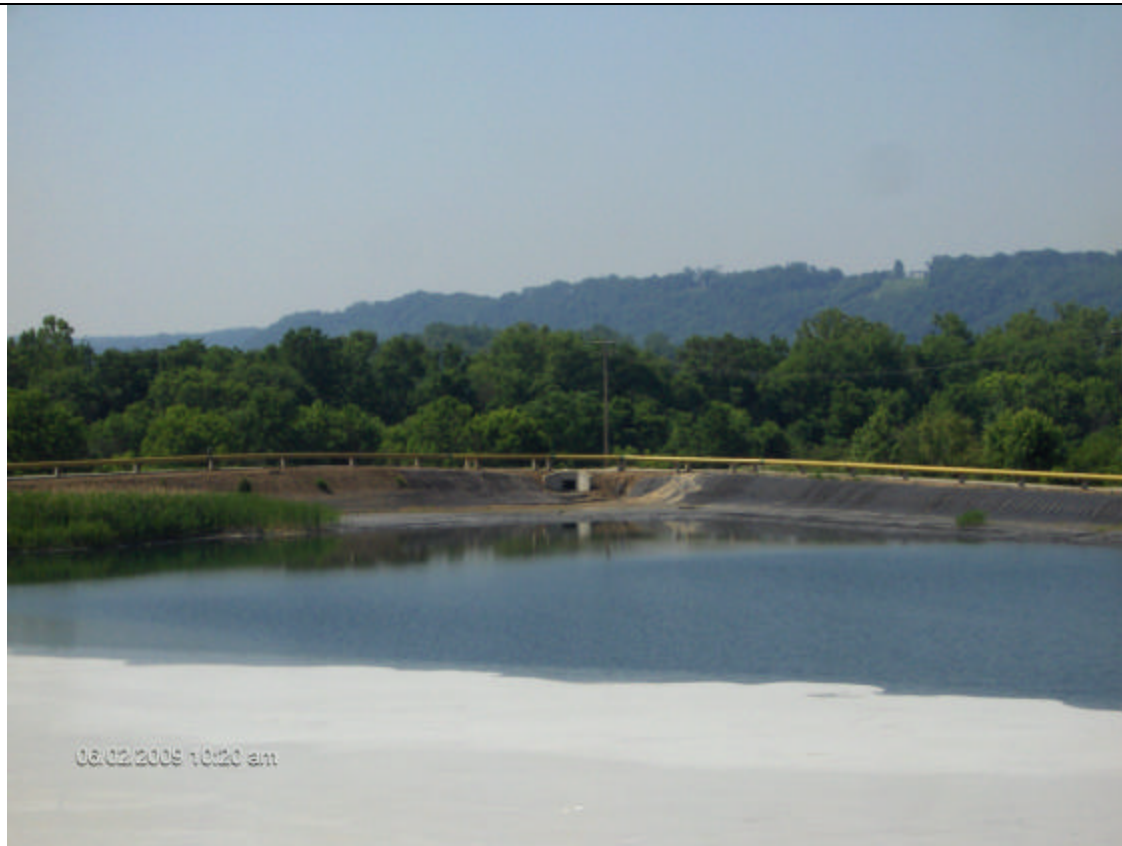
Photo Number:  
16

Description:  
Emergency  
overflow inlet at  
southeast corner  
of Clear Pond

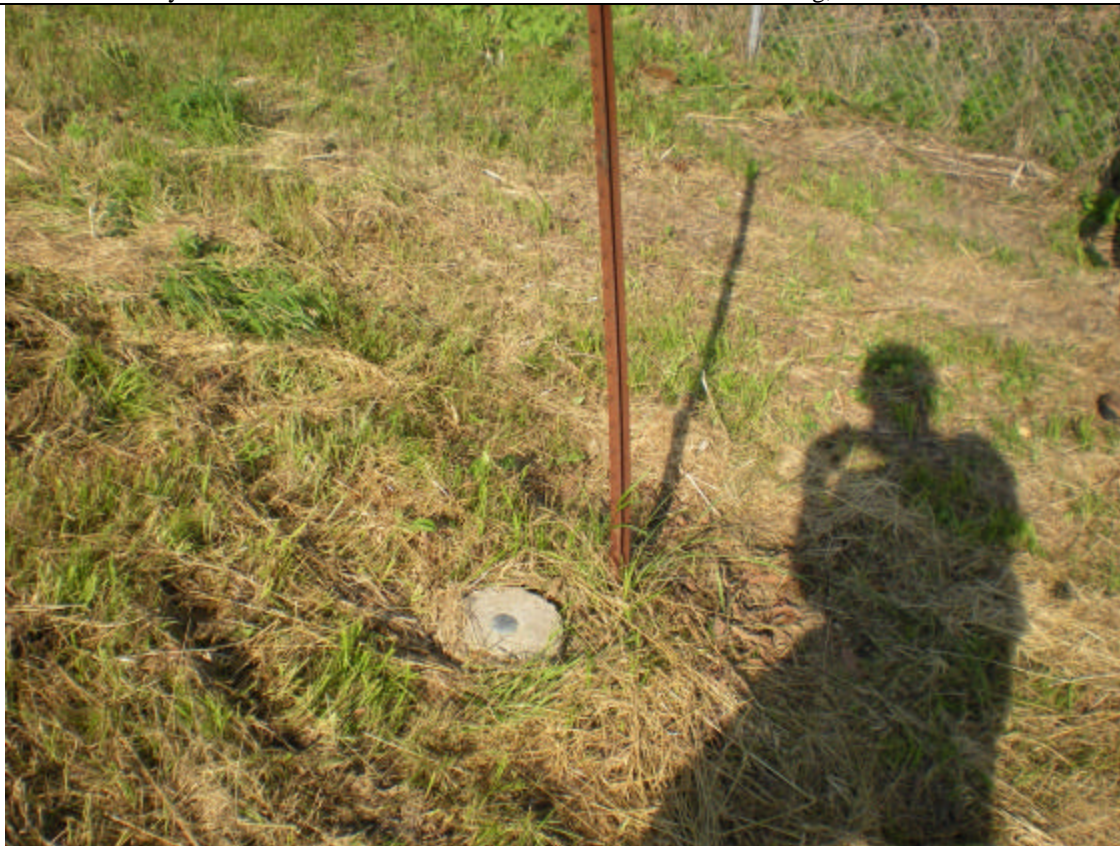
Surface monitoring point located on west embankment of original structure

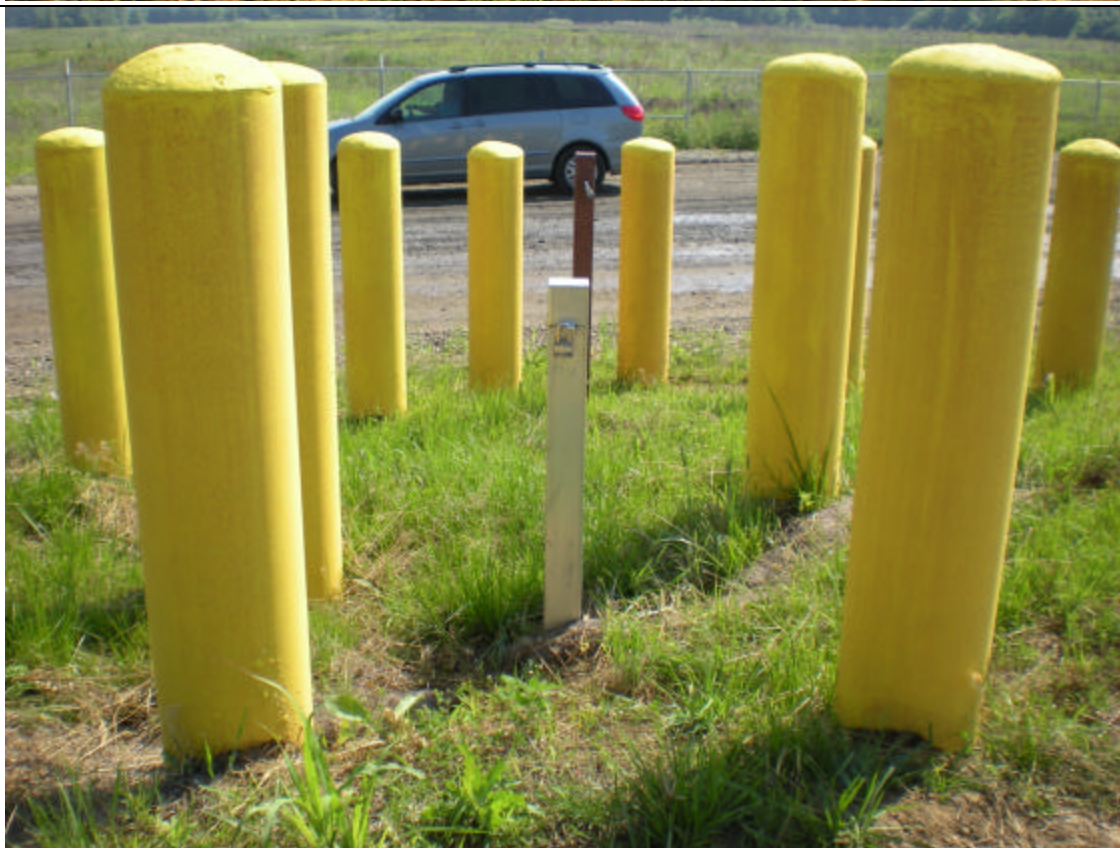
Slope indicator located near toe of slope on original North Embankment. Monument is heavily protected by concrete bollards.
